Additional **Figures:**

Materializing Exposure: Developing an Indexical Method to Visualize Health Hazards Related to Fossil Fuel Extraction

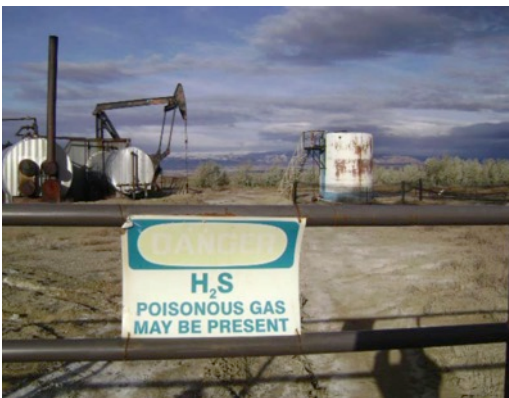
Figure 2: Current regulations merely require posting signs warning of the H₂S hazard on the wells' fencelines. These signs themselves are corroding.

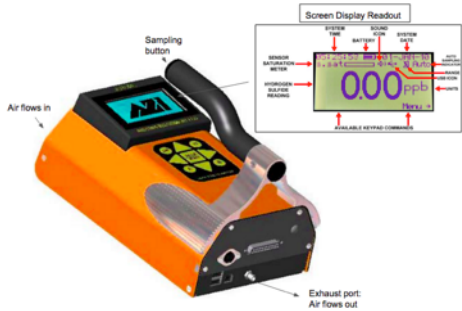
Figure 3a: Jerome Meter (Arizona Instruments, LLC 2015): Jerome Meter made by s Instrument. This handheld device measures Hydrogen Sulfide digitally over the course of a few seconds (Arizona Instruments, LLC 2015: 2, 12).

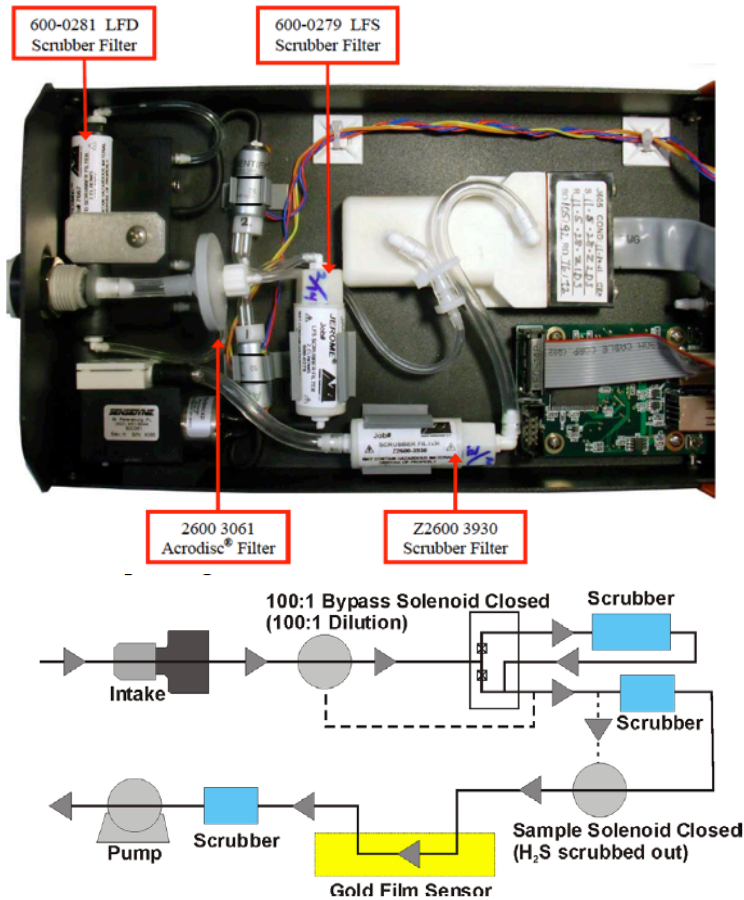
Figure 3b: The inside of a Jerome Meter and accompanying diagram of how it operates (Arizona Instruments, LLC 2017). The sample of air passes through sensing technology contained within the black-boxed body of the instrument. The gold film sensor is encased and sealed shut within the instrument.

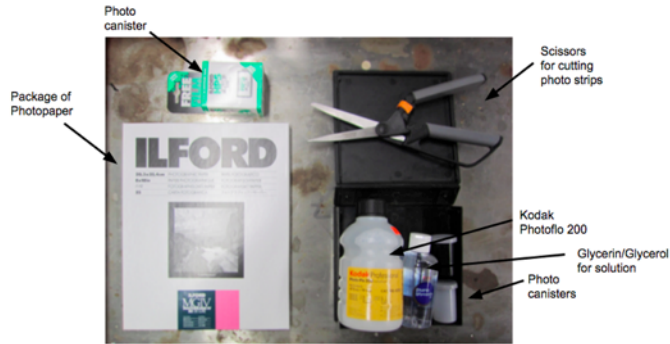
Figure 4: H₂S Photopaper Sensing Tool Components (<http://publiclab.org/wiki/hydrogen-sulfide-sensor>) Photo canisters, package of photopaper, scissors, and glycerol solution components used to make the H₂S sensing tool. H₂S reacts with the silver halide on the photo paper.

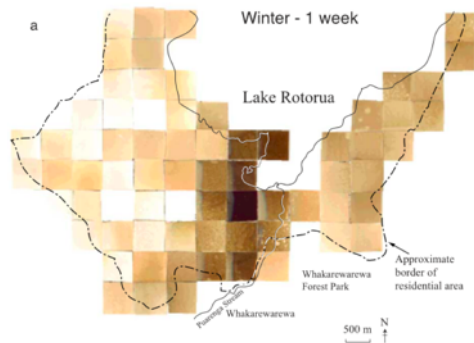
Figure 5: Horwell's results around Lake Rotorua. H₂S Distribution Map from Horwell et al. 2005. The map shows how volcanically produced H₂S travels through the city of Rotorua in New Zealand. The tarnished photopaper strips overlay a map with the locations in which they were placed over the course of 1 week. Darker squares indicate greater degrees of tarnish and higher levels of H₂S (Horwell et al. 2005: 264).

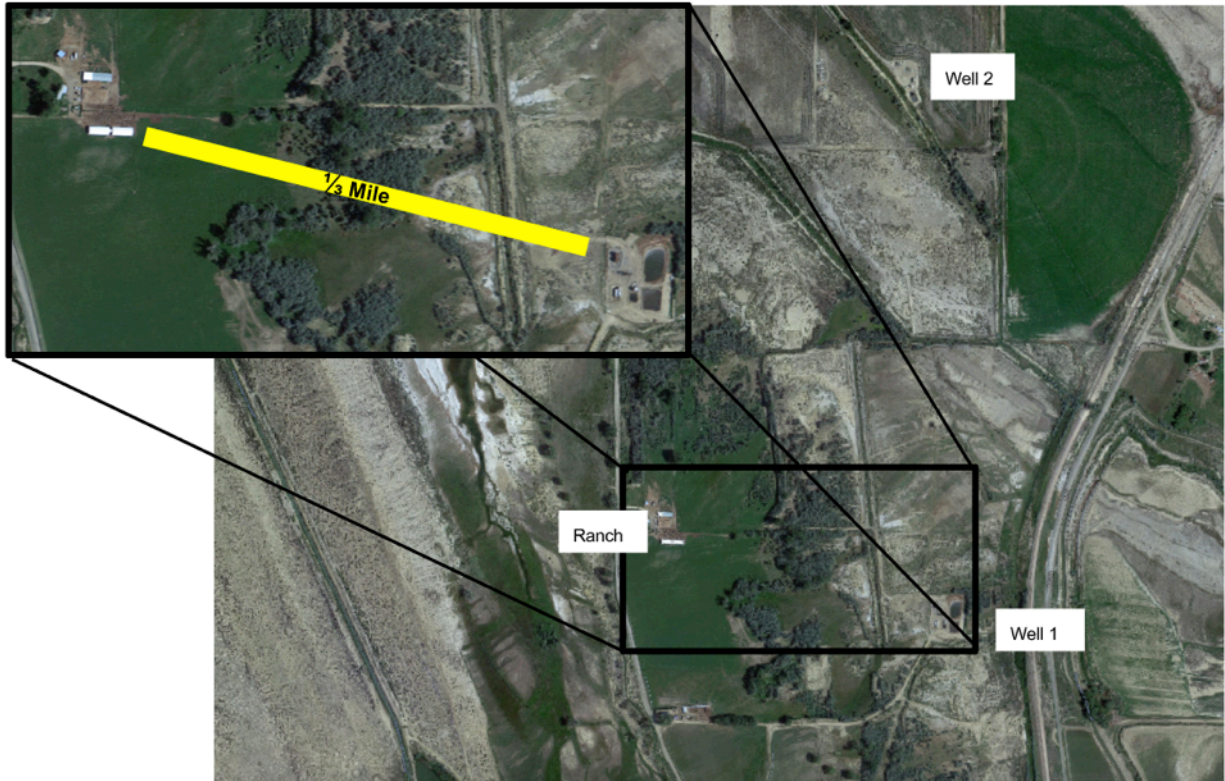
Figure 7: The Bakers' home is a third of a mile away from oil wells and the produced water pits that discharge into the irrigation system on their ranch

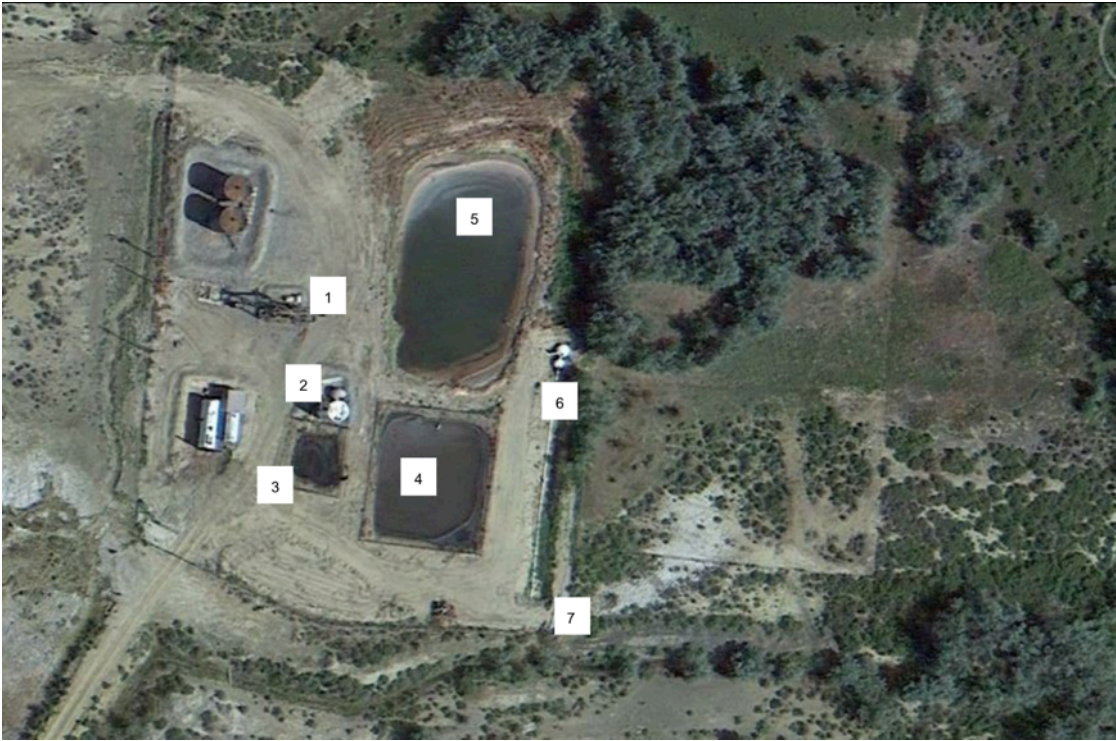
Figure 8: Series of impoundment/drainage/irrigation photos. In theory, the “impoundments” clean the wastewater by allowing heavy hydrocarbons, such as oil, to sink to the bottom of the pits and separate from the wastewater produced during extraction

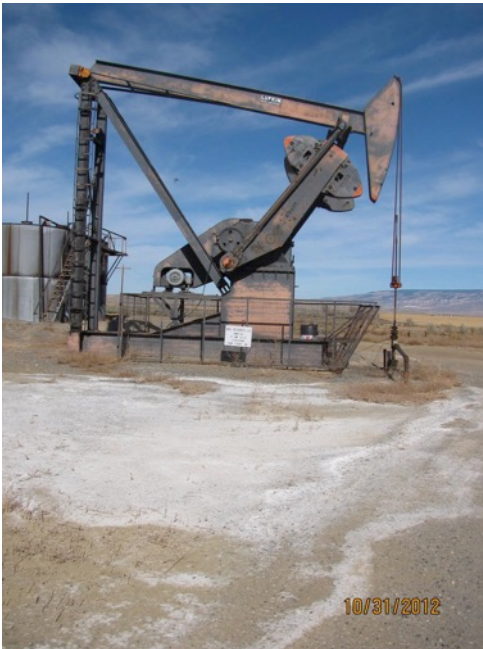
Point 1: pump jack

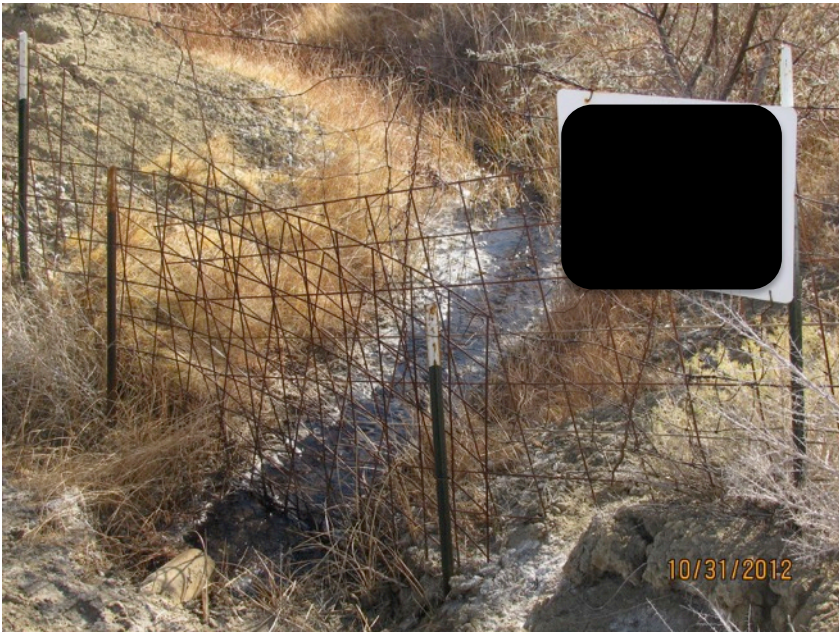
Point 7: After separation, the remaining water should meet the state's standard of clean up-- allowing it to be discharged into the irrigation system drains

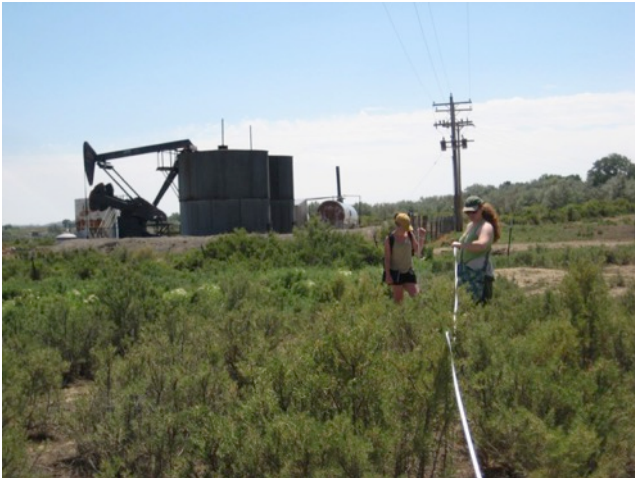
Figure 10: The Bakers', Deb, and her two interns conducted four rounds of testing for HS on their property- three trials of the photopaper and four Tedlar bag grab samples of air.

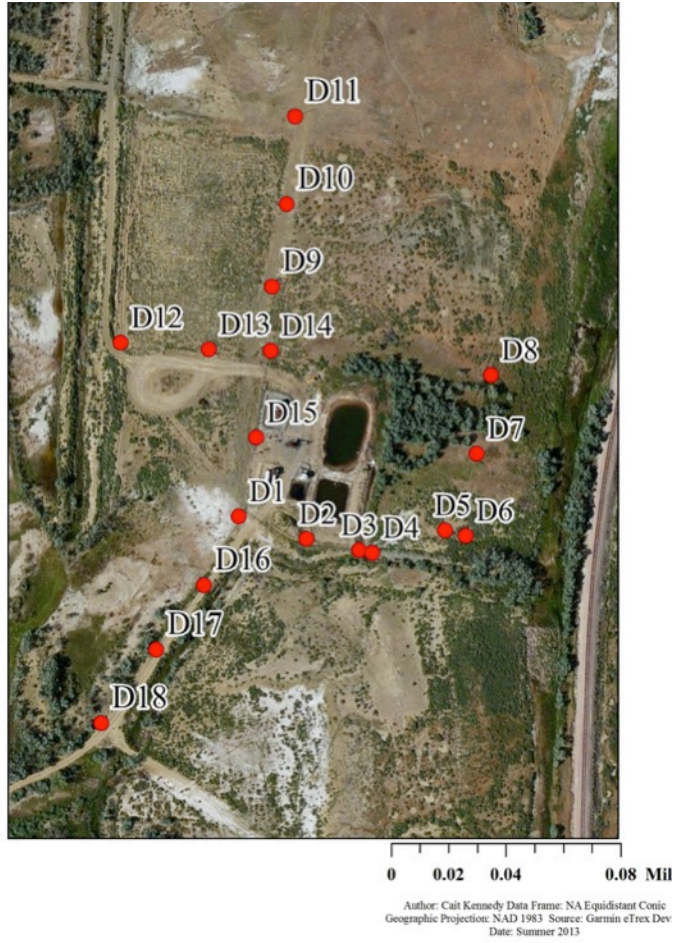
Figure 12: Photographic canisters testing locations on the Baker Ranch in Wyoming. Canisters were labeled and placed at set distances along roads surrounding a well. Image Courtesy of Caitlin Kennedy, 2013.

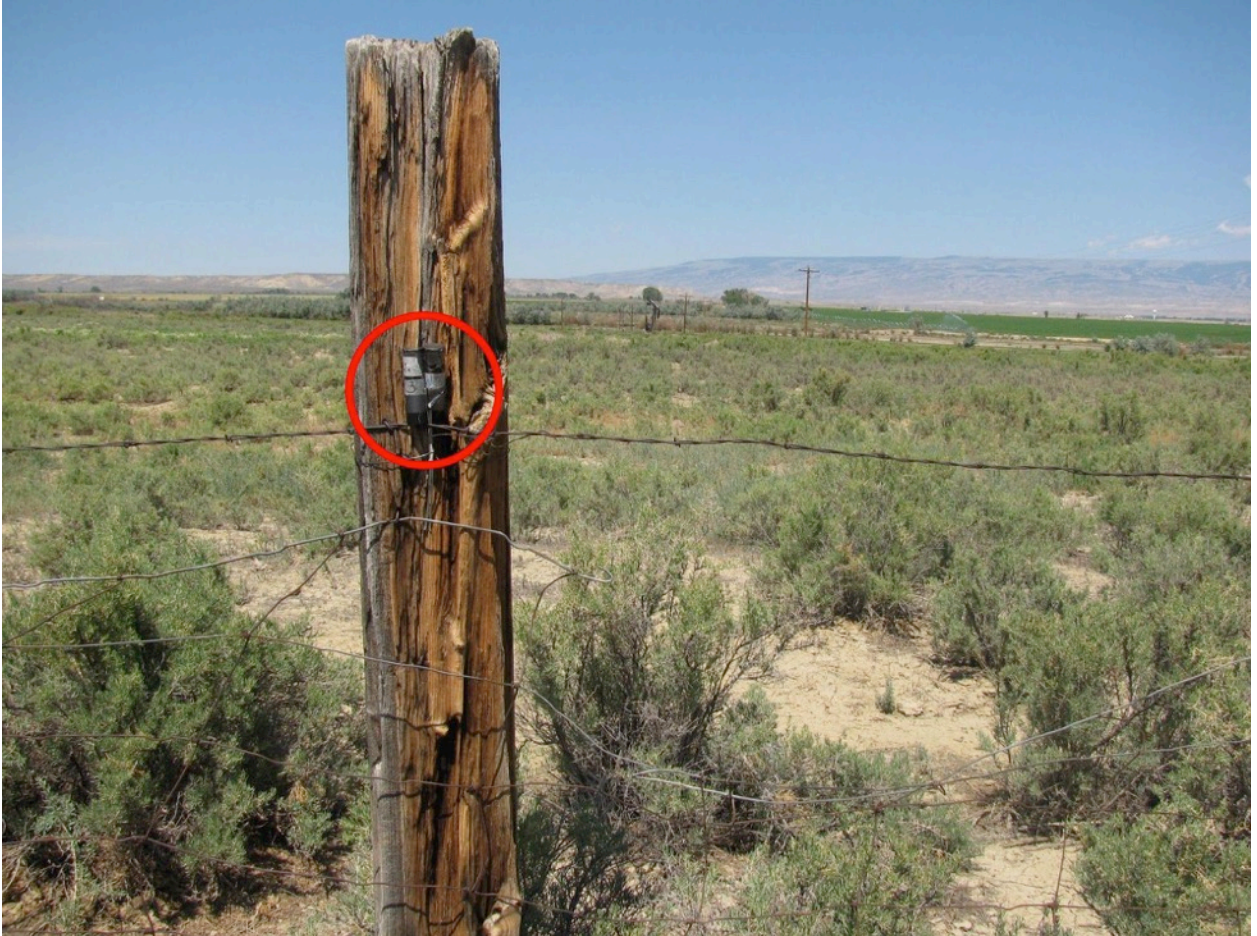
Figure 13 shows a canister in location

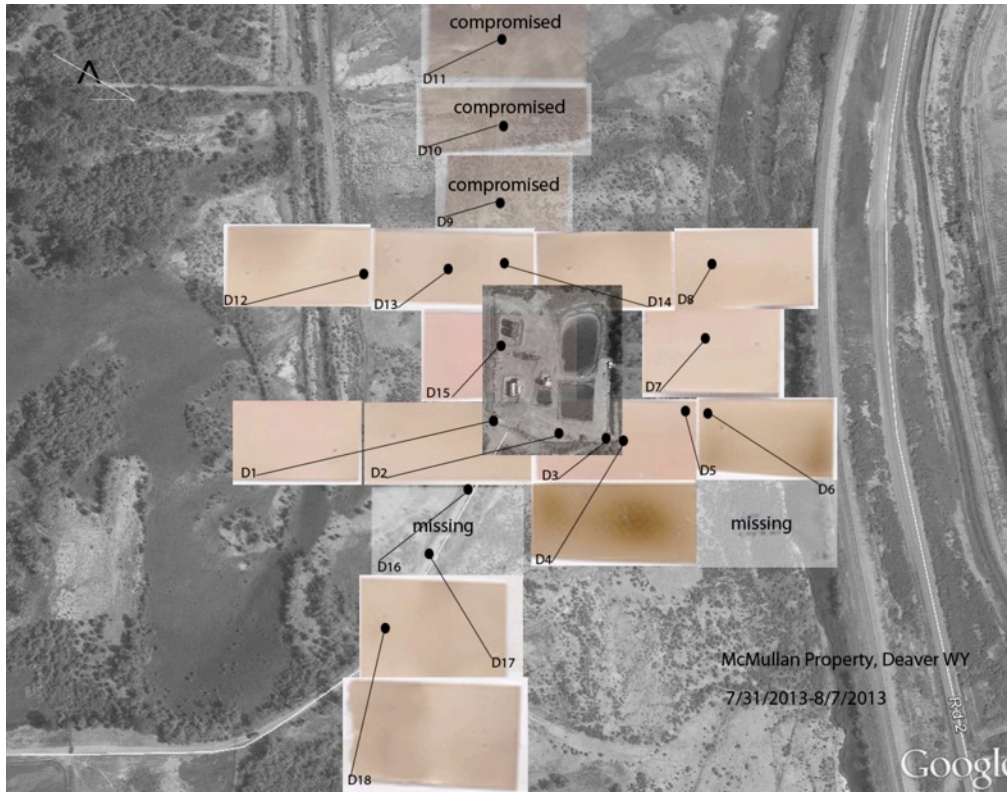
Figure 14: Some canisters were lost as they soon discovered how difficult it was to find the small canisters in the brush, other canisters were compromised by either the strips falling from the canisters or the canisters becoming dislodged. We also experimented with different approaches to presenting the data, here is test of how the strips looked over a black and white satellite image.

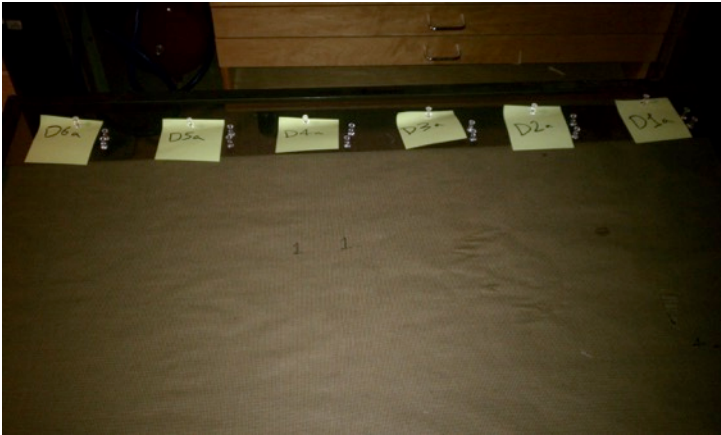
Round A: Drying Rack

Figure 15: They capped each canister they recovered and mailed the collection back to Northeastern where we developed them in a standard photographic darkroom.

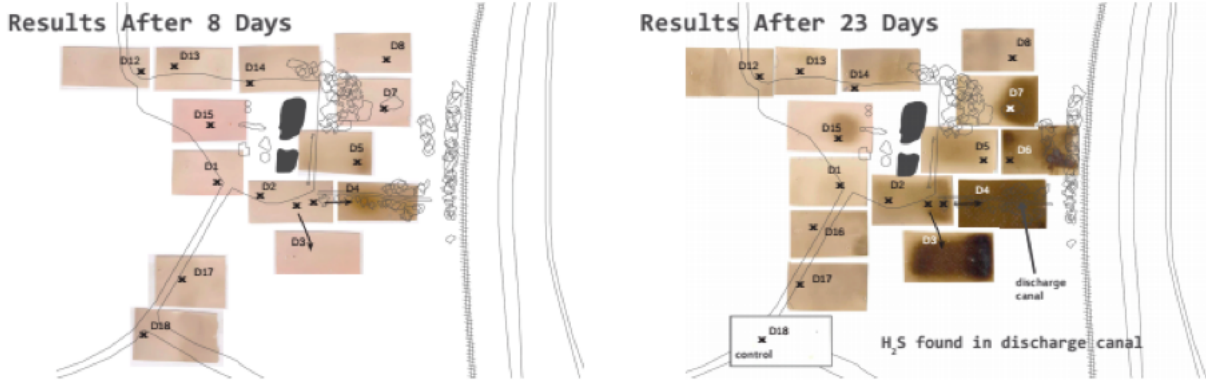
Figure 16: Map of tarnished H₂S photo strips at a well site on Baker Ranch. Tarnished photo strips show areas with higher levels of H₂S. Points D9, D10 and D11 were compromised (knocked over or lost).

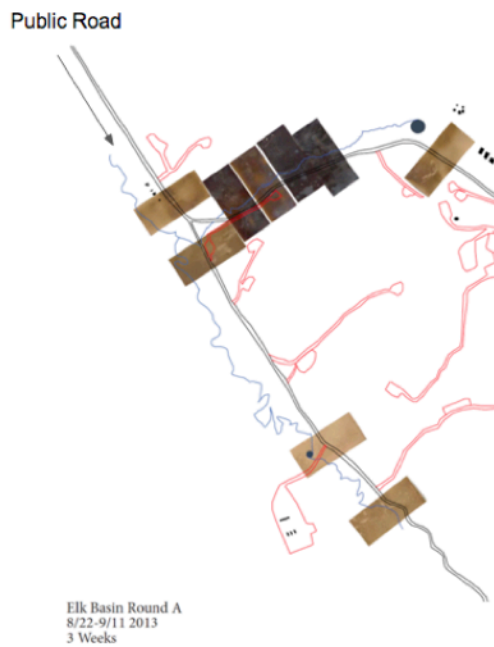
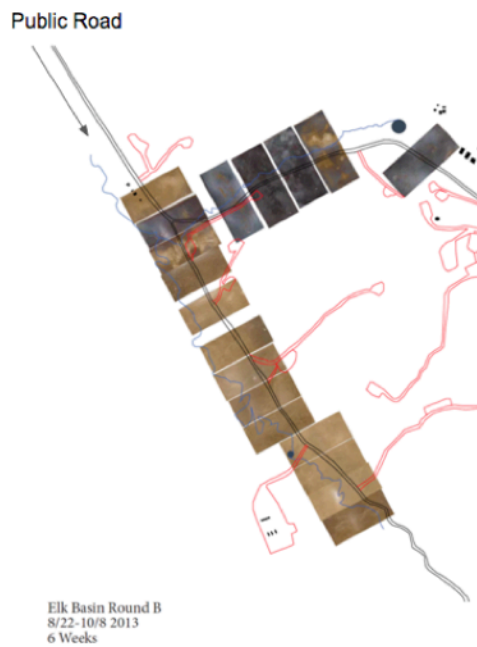
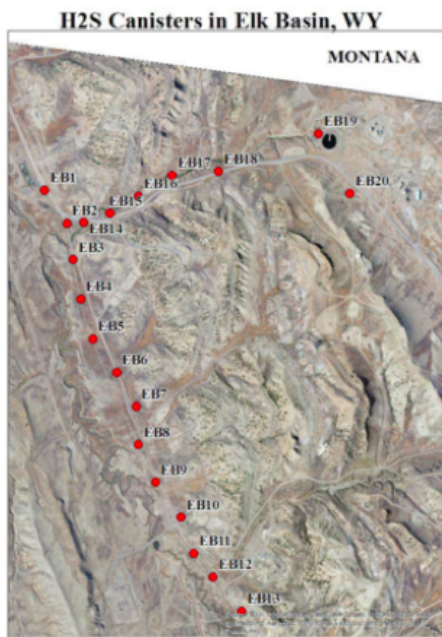
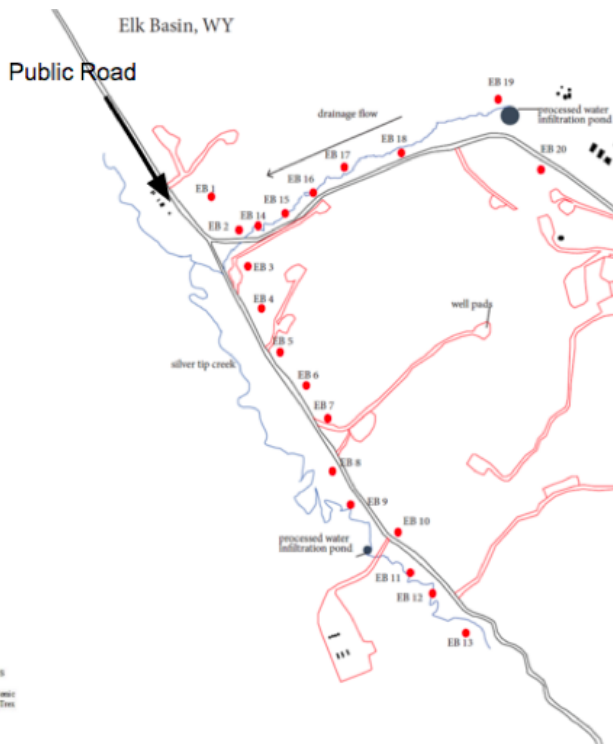
Figure 21: Map of tarnished H.S. photo strips at Legend Rock State Park over four weeks (upper left) and three months (upper right) Map of H.S. canister results from Elk Basin Oil Field in Wyoming (lower). Note that H.S. is found along the Public Road (Image Credit: Meghan McLaughlin 2013).
